Embrittlement of a Platinum-Iridium Screen

10 January 1999

G. L. STECKEL and N. MARQUEZ
Mechanics and Materials Technology Center
Technology Operations

6. AUTHOR(S) G. L. Steckel and N. Marquez				
7. PERFORMING ORGANIZATION NAME(S) AND ADDRESS(ES) The Aerospace Corporation Technology Operations El Segundo, CA 90245-4691			8. PERFORMING ORGANIZATION REPORT NUMBER TR-99(8565)-2

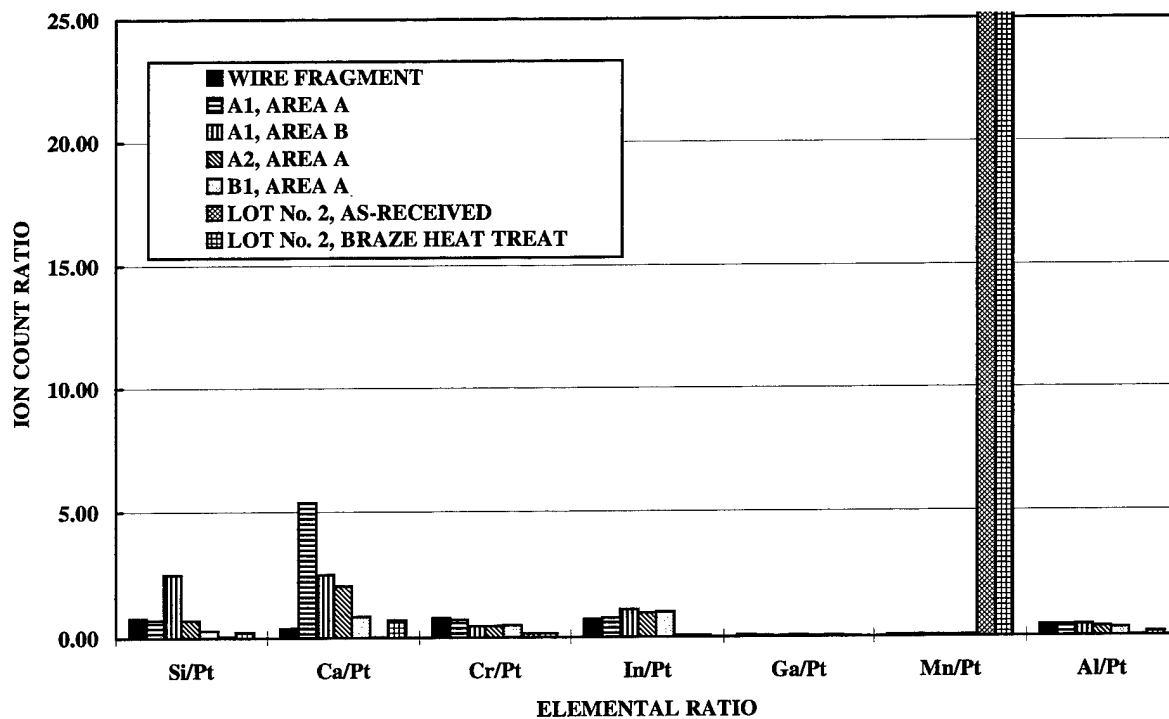
counts is indicated in parentheses for each element or compound. Spectral data are presented for two separate areas on Sample Nos. A1 and A2, and for one area on all other samples. Similar elemental spectra were obtained for the wire fragment, the two areas on Sample Nos. A1 and A2, and the one area on Sample No. B1. The primary impurities were Cr, Rh, Al, In, Si, and Ca. Rh was not included in Table 2 or Figure 13 since the presence of Rh is expected and is of no concern. Indium was the most surprising impurity and appeared to be present in significant levels, although not at concentrations sufficient to be detected by SEM/EDX. Cr, Rh, Si, and Ca were all detected in the bulk chemical analysis (Table 1), while Al was not detected, and In was not checked for in the bulk analysis. Elemental mapping indicated that the Cr, Rh, Al, and In were distributed uniformly throughout the cross section. The Ca and Si were associated with one another and appeared to be present as distinct particles, as shown by the elemental maps in Figure 14 for Sample No. A2, Area B.

Figure 13. Primary impurities detected in SIMS analysis of cross sections of Pt-Ir wire fragment and Mesh A, Mesh B, and Lot No. 2 screens.

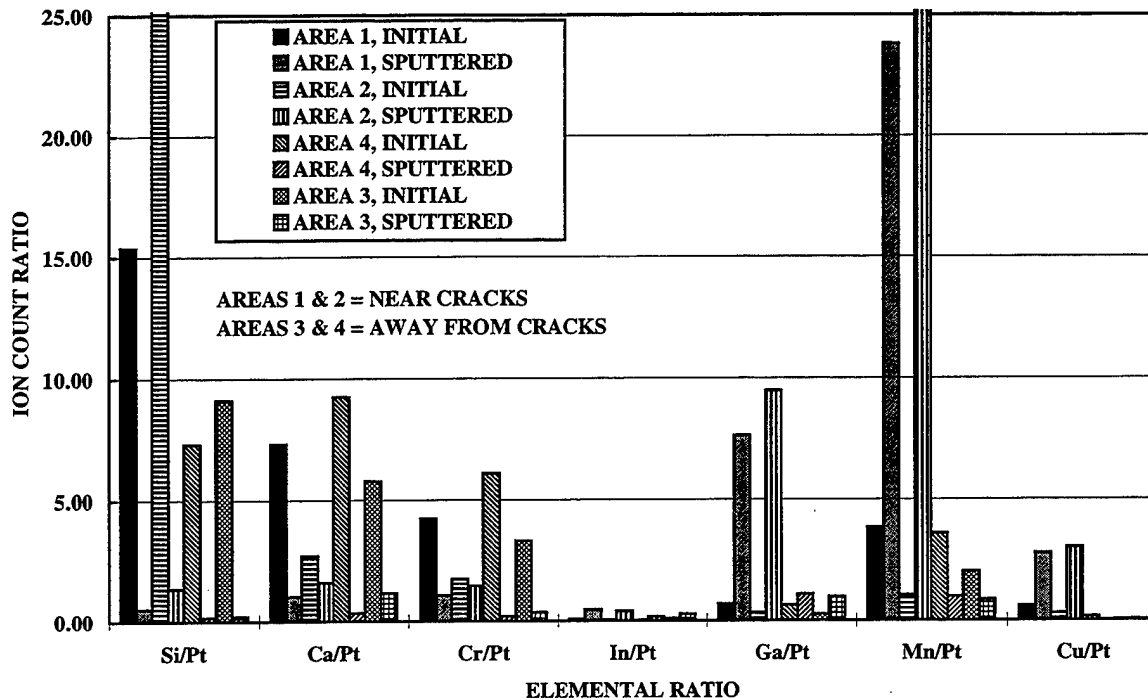
Figure 16. Primary impurities detected in SIMS analysis of surfaces of Pt-Ir screen sample No. A3.

the wire strands, one high point that did not have any cracks, and one saddle point. The areas analyzed on the cracked wires were adjacent to the cracks. Initial surface spectra were obtained at each area followed by sputtering for up to 90 min. Additional spectra were taken after 30, 60, and 90 min of sputtering. Results for the initial and final spectra will be discussed. The 30 and 60 min spectra were either intermediate between the initial and final spectra or were very similar to the final spectra.

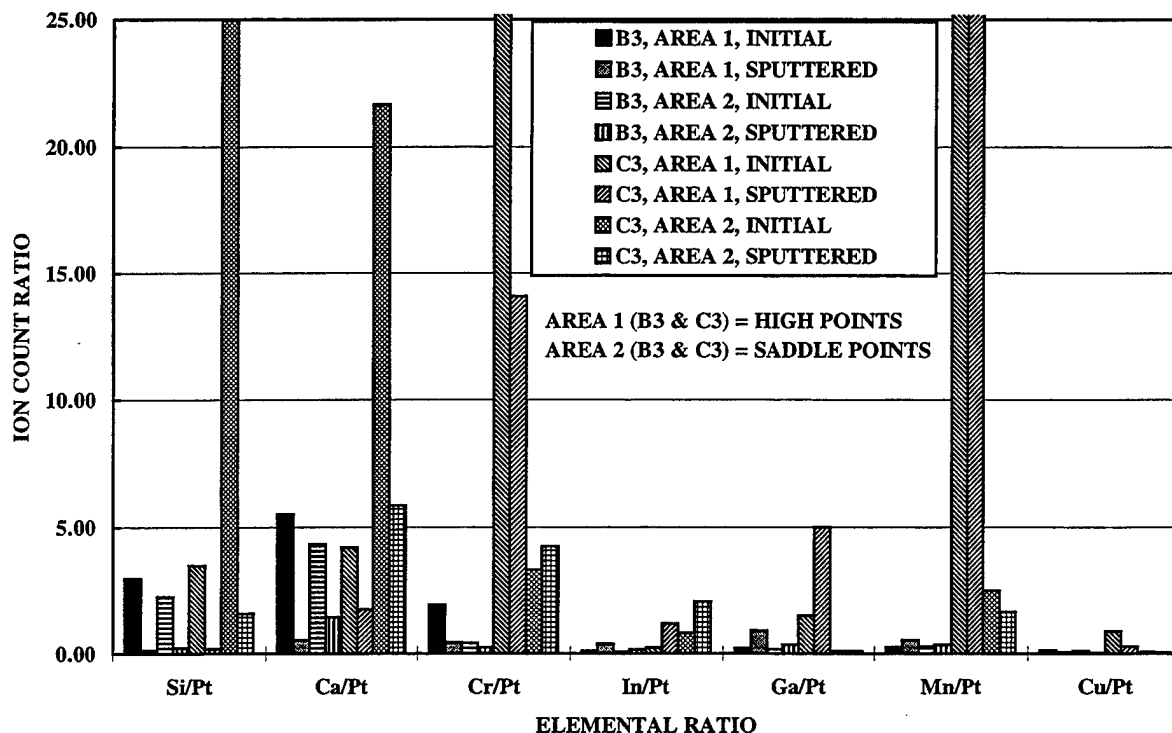
Figure 17. Primary impurities detected in SIMS analysis of surfaces of Pt-Ir screen sample Nos. B3 & C3.

after up to 90 min of sputtering. For Sample No. B3, similar results were obtained at the high point and saddle point. Aside from Al from the catalyst particles, Si and Ca were the primary impurities on the surface. Both decreased significantly during sputtering. There were only traces of In, Ga, Mn, or Cu before or after sputtering.

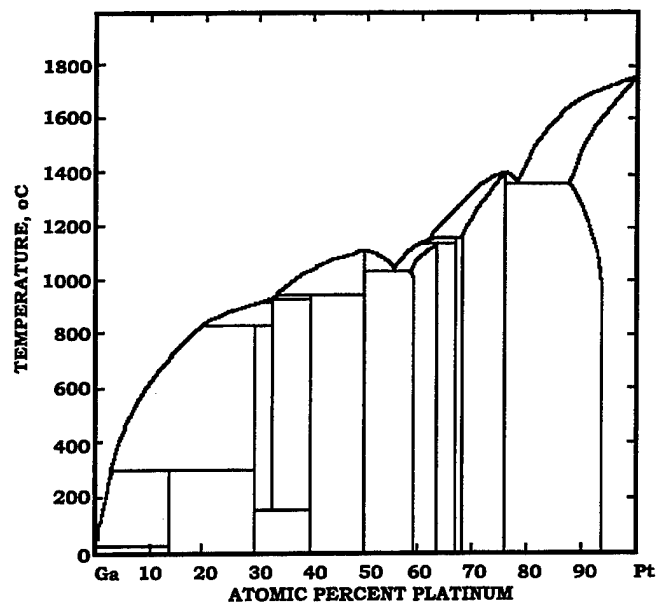
Another potential embrittlement mechanism is the formation of low-melting eutectic or intermediate phases at the grain boundaries. In this case, the alloy usually fails in a ductile mode at temperatures up to or approaching the melting point of the grain boundary phase and in a brittle fashion at higher temperatures. The Pt-Ga and Pt-In phase diagrams^{9,10} (Figures 20 and 21) demonstrate that these systems form several intermediate phases with melting points below 900°C (1650°F). This embrittlement mechanism is quite common for Pt alloys and has been reported to occur due to contamination with low concentrations of Si, Ag, K, Pb, and Se.¹⁷ Like the liquid in LME, the embrittling phase is usually easily detected on the brittle fracture surface, but in some instances is present in monolayers that are not easily detected.^{7,11,12}

Figure 20. Platinum-gallium phase diagram.

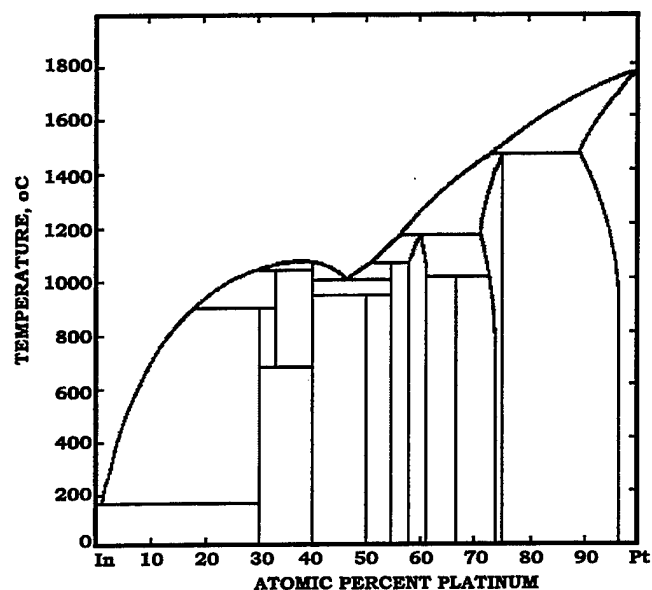
Liquid-metal embrittlement (LME) is the catastrophic brittle failure of a normally ductile metal when coated with a thin film of a liquid metal and subsequently stressed in tension.⁸ The fracture is usually brittle intergranular, with little indication of crack branching or striations to indicate slow crack growth. In general, LME fracture surfaces are completely covered by the liquid metal. However, in some cases very small quantities of liquid are required, making detection of the liquid metal on the fracture surface very difficult. LME is usually caused by low-melting-point metals. Liquid metals that have been reported to cause LME include lead, bismuth, cadmium, mercury, lithium, zinc, gallium, indium, and many others. The fact that Ga and In were identified on the Pt-Ir wire surfaces adjacent to brittle cracks is a strong indicator that the fractures were caused by LME by one of these elements or by a Ga-In alloy. No reports of LME of Pt or its alloys by In or Ga were found in the literature. However, Ga and In have been reported to cause LME in several other face-centered cubic metals, including Al and Cu. LME usually occurs at temperatures near the solidification temperature of the liquid. An increase in temperature usually decreases embrittlement, leading to a brittle-to-ductile transition. In the present case, the experimental results for tensile tests on extracted wires suggested that the Pt-Ir wire was ductile at low temperatures (23 and 300°C; 73 and 570°F), but brittle at 900°C (1650°F). The melting points for Ga and In are 30 and 156°C (86 and 313°F), respectively. Thus, LME would be expected to occur at lower temperatures. On the other hand, Mn and Cu were associated with the Ga and In on the wire surfaces. Thus, a more complex LME interaction may have occurred.

Figure 21. Platinum-indium phase diagram.
